Failure Mechanism of the Toppling Rock Slope with Different Numbers of Free Faces Caused by Excavation: a Case Study in Jiacha Hydropower Station (China)

Shao-Ping Huang^{1,2}, Kai-Ming Cao^{1,2}, Chang Zhou³, Heng-Lin Xiao^{1,2}, E-Chuan Yan^{4*}, Lu Cong⁵

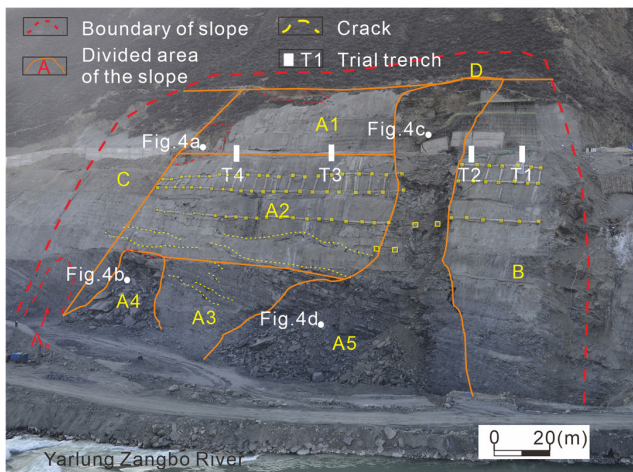
According to the deformation characteristics based on the monitoring results, and failure mechanism, this slope was divided into four parts (Fig. 3): the bending deformation areas (A1, A2, A3), the collapse areas (A4, A5, A6), the potential collapse areas (B and C) and the slope influence area (D). Their deformation characteristics were analyzed in detail.

Fig. 3 Division of deformation area. (Note the white rectangles are the location of four trial trenches named T1 to T4.)

Potential sliding area (B and C area): B and C area are located on both sides of the slope and are currently stable as a whole, with only partial cracks developing on the slope surface, but under the combined effect of groundwater and unloading, further deformation and damage to the slope will occur, leading to overall instability. For example, the toe of the C area (A6) collapsed on Feb. 9, 2015 (Fig. 3), and many cracks were formed.

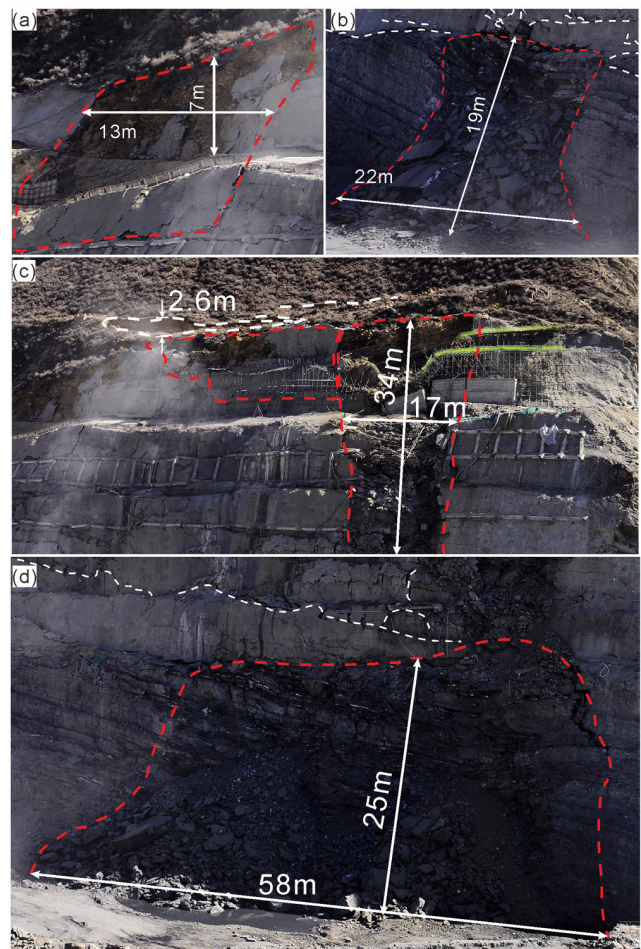
Collapse area: A4 and A5 were firstly collapsed and deposits accumulated at the toe of the slope. The shapes of those areas were a pyramid with approximately 500 m² and 3300 m², respectively. There were some cracks on both sides of the A4 and A5. The majority of the deposit are debris (Fig. 4(b, d)).

Fig. 4 Deformation characteristics of sub-divided landslide. a) collapse in the lower left corner of the A1 area; b) A4 area; c) A1, D, and upper part of A5; d) downhill portion of the A5 area

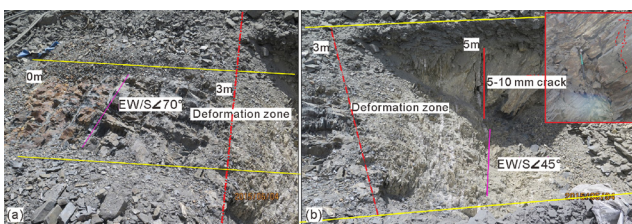
structure. It should be noted that the trial trench explored that the inclination of the strata gradually decreased from upstream to downstream. In the T1 trial trench, the inclination of the strata in the stable zone (0–3 m) is 70° (Fig. 5(a)), but in the deformation zone, it changes to 45° (Fig. 5(b)). A crack was observed with the width of 5–10 mm (Fig. 5(b)), and other one also was found in the rock perpendicular to the strata. In the T2 trial trench (Fig. 6(a)), the inclination decreased from 55° to 10° from the uphill to the downhill side of the trial trench. Three cracks were formed perpendicular to the sliding direction of the slope and extended into the slope (Fig. 6(b)).

Fig. 5 Strata exposed by T1 trial trench, a) upstream of the B area, b) downstream of the B area

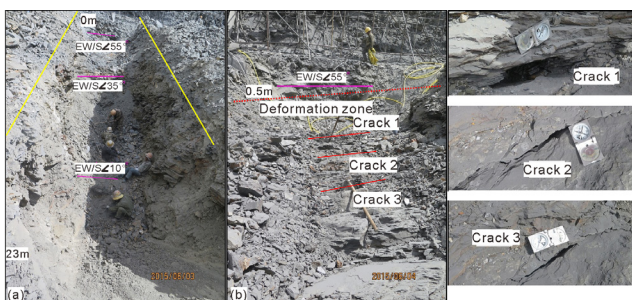
Fig. 6 Strata exposed by T2 trial trench, a) upstream of the B area, b) downstream of the B area

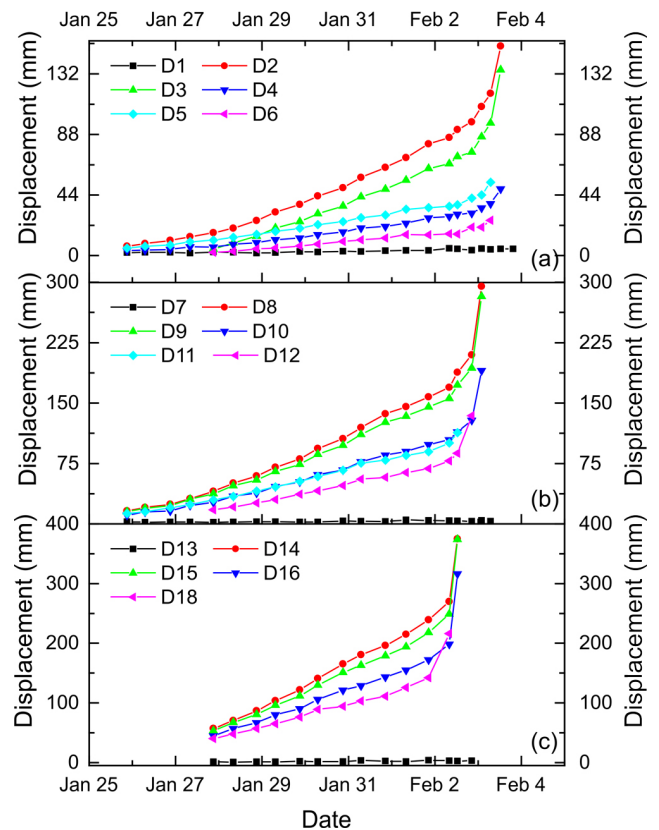
Fig. 7 shows the accumulated displacement of the slope surface. All the curves have a similar trend: the displacement of the measurement points increased with a constant velocity initially and then rapidly accelerated after Feb 2. The D2 and D3 had the largest displacement in the potential sliding area (Fig. 7(a)). Furthermore, they gradually increased at an average velocity of 13 mm/day, but their velocity rapidly increased to 80 mm/day after Feb 3. The displacement of the middle portion (D4, D5, and D6) is smaller than that of D2 and D3 whose locations are close to the collapse area. However, the displacements at points D1, D7, and D13 were very small (< 5 mm) (Fig. 7(b)). In addition to the above points, other monitoring points were located in the bending deformation area. The displacement of the rock slope

Fig. 7 Relation curves of the long-term external deformation monitoring data with time, a) B area, b) A area, c) C area

gradually decreased from the upstream to downstream and from the east side to the west side. The displacement of those points tended to rapidly increase with a high velocity. For example, the average rate of the D14 (Fig. 7(c)) was 38 mm/day which is three times of the D2.

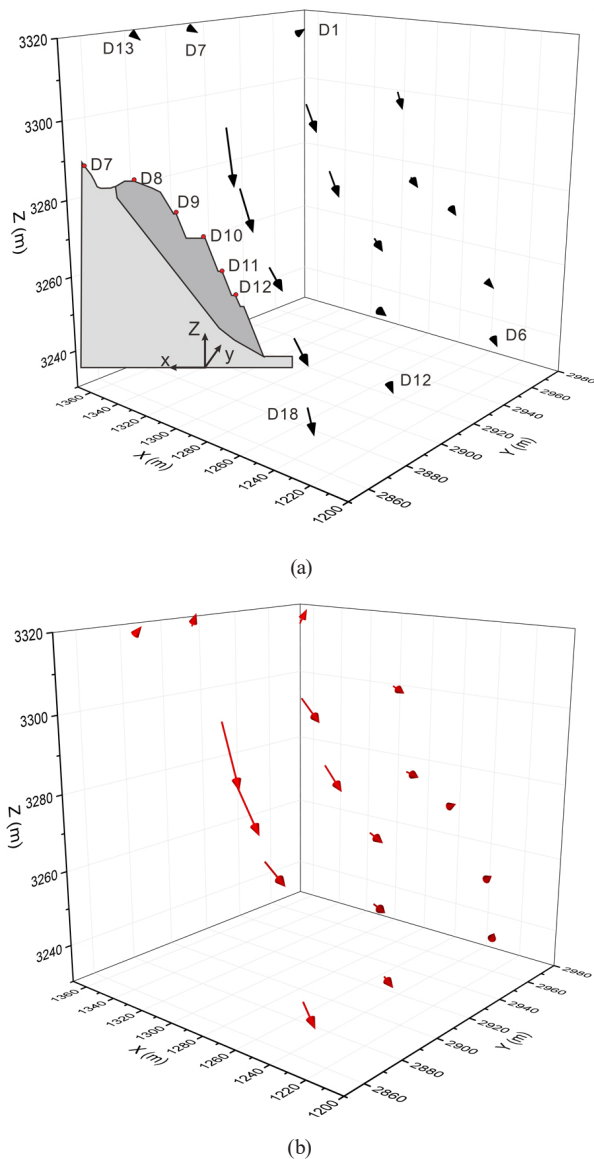
The 3D displacement vectors of the monitoring points are depicted in Fig. 8 at different times. All monitoring points have different degrees of deformation in B area. This is a significant finding with regards to no matter in which direction, D1 displacement was the smallest, while D2 was the largest. In other words, the displacement of two adjacent points had a significant difference in each direction. From the top to bottom of the monitoring points except for D1, the displacement gradually decreases, which indicates that the anchoring project on-site limits the development of slope cracks. Furthermore, Fig. 8 shows that all monitoring points in B area had the largest displacement in the X direction. However, the collapse of the downhill part of the slope provided a free face for the B area. As a result, a slope with three free faces was generated, this slope occurred a typical 'nodding and slouching type' toppling deformation due to gravity and external forces. The slope slipped along the sliding direction and the deformation mainly occurred in the middle

portion. As shown in Fig. 8, the different portions have different sliding directions. The displacement vectors direction of the A1 area firstly vertically downward, and then gradually changed to the horizontal direction. At the same time, the amount of the vectors also increased. However, in the A2 area, the direction of those vectors became more and more horizontal. The horizontal angle of the displacement vectors at the uphill side of the A2 (D12, D18) gradually decreased and their amount also decreased. In the B area, the displacement vectors' direction and values were different from that in the A1 and A2. First, the directions of the vectors slope downward (Fig. 8(a)), but on February 2, they become upwards slope (Fig. 8(b)). Secondly, the values of the vectors were smaller than other monitoring points. Compared with

Fig. 8 3D displacement velocity of the monitoring points on (a) Jan 30; (b) Feb 2

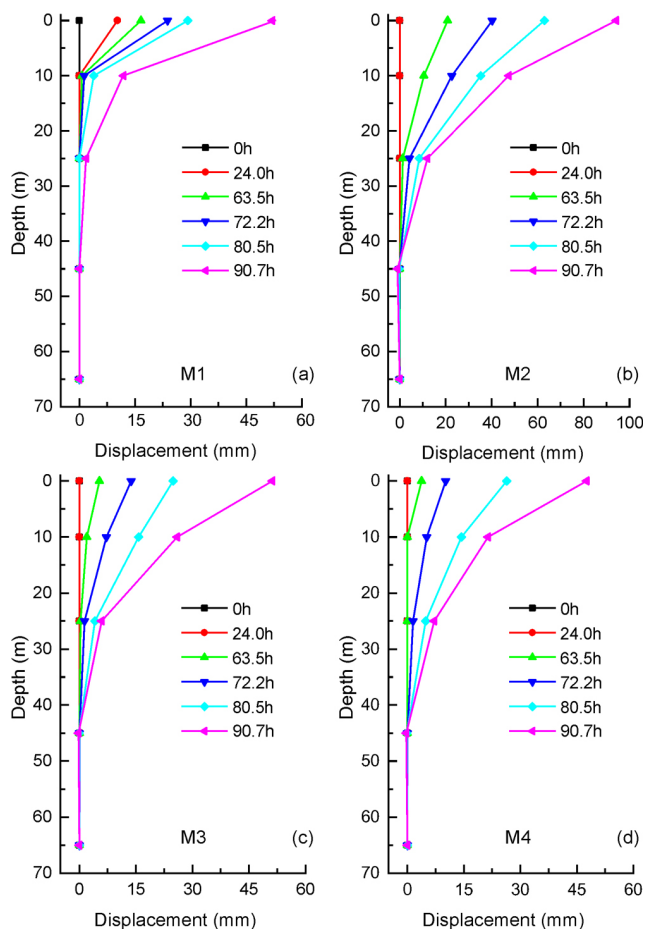
In order to understand the inside deformation characteristics of the slope, multi-point extensometers were installed at 0 m, 10 m, 25 m, 45 m and 65 m away from the slope surface. The monitoring results are as graphically demonstrated in Fig. 9. Firstly, the monitoring points at M2 (Fig. 9(b)), which

Fig. 9 Multipoint monitoring results, a) M1, b) M2, c) M3, D) M4

is close to the collapse zone A1 with two free faces, had the largest displacement and deformation depth compared with others. The deformation of these monitoring points gradually decreased as the increase of depths and reach 0 mm at depths of 25–35 m, which indicated that the deformation depth of the slope is 25–35 m. The monitoring point at M3 (Fig. 9(c)) had a lower evaluation and smaller displacement than M2. Secondly, the displacements of the monitoring points accelerated, especially near the shallow slope. As result, the collapse area was produced. Moreover, it can be seen from Fig. 9 that at the beginning of the monitoring work, there is no displacement at all points at the time of 0 h, but at 24 h, the deformation first begins at M1 and reaches a depth of 10 mm. After that the deformation rate begins to decrease gradually at M1 after the collapse area occurred and is mainly attributed to the fact the anchoring system still had a reinforcement effect to stabilize the slope. Thirdly, it also can be seen that the maximum displacement of M2 reached 85 mm which is larger than that of M3 (44 mm), indicating that the rear of the slope squeezes the front movement. In addition, the displacement monitoring results (Fig. 9 (a, b, c, d)) also show that the displacement gradually decreased from upstream to downstream, indicating the deformation model of the slope is toppling deformation. A5 area failure provides a new free face for B area and a new rock slope with three faces is generated. The shallow part of the slope integrally slips along the sliding surface. However, in the deformation area, the monitoring points are closer to the deposit area (A5) and have larger displacement, which could be inferred that the slope gradually deformed towards two open surfaces. The results of the drilling and deep deformation monitoring also show that the closer to the free face, the greater the depth of the deformation zone. This can be explained by the fact that the formation of the upstream collapse area gives rise to one free face turned into two free faces in the slope. In addition, this agrees well with the external deformation monitoring results.

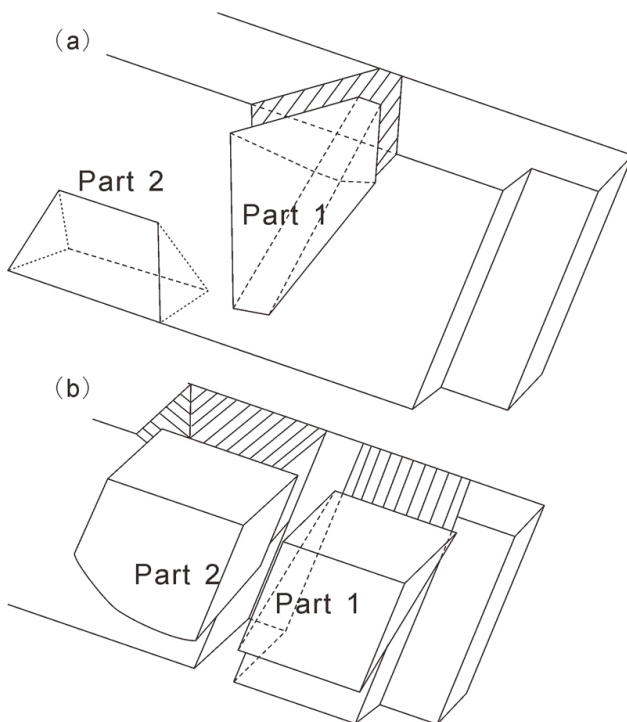
Single free face rock mass slope is mainly controlled by the dominant joints set and wedge sliding occurred in this slope (Fig. 13(a): Part 1). Moreover, this slope was also influenced by the unloading effect, so the prismatic sliding occurred in the slope toe (Fig. 4). In the double free faces rock mass slope, the combination of the free face and joint set controls the failure model of the toppling rock mass slope [33]. This failure mode can be summarized as unloading and rebounding – dumping and breaking – bulging – shearing – overall failure. In this paper, three dominant joints cut the strata and wedge sliding along the intersection line of two discontinuities occurred [34] (Fig. 13(b): Part 2). However, after the upstream potential collapse area (B area) is affected by the collapse area and forms a three-face void, the rock slope with three free faces could first bend and then slides along a discontinuity under the action of its own weight and unloading (Fig. 13(a): Part 1) [26–27, 41].

Fig. 13 Sliding and toppling failure model for rock mass slope with (a) one free face; (b) double, and three free faces

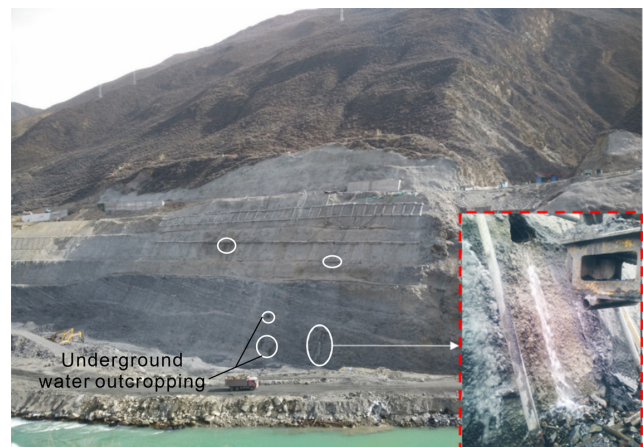
4. Underground water: Data from the detailed field investigation shows that the factor of safety for slopes can decrease significantly with increasing the groundwater level, and the impact is more significant on slopes with steeper joints. For example, after the rain and snowfall in mid-January 2015, ice and snow melt water infiltrated along the surface cracks, and the infiltration of ice and snow melt water reduced the physical and mechanical strength of the rock body on the one hand, and made the deformation modulus of carbonaceous slate in the rock body of the slope significantly reduced on the other hand, making the slope appear deformation and compression space. In addition, the volume of the groundwater expands after freezing, and the ice-splitting effect is unusually powerful, further increasing the crack opening width. Furthermore, the alternating effect of positive and negative temperatures during day and night, and the repeated freezing and thawing of fracture water, lead to large deformation of the slope. Thus, the slope had obvious deformation where the groundwater outcropped. Fig. 10 shows the outlet locations of groundwater, and this underground water outcropping is mainly located in the collapse area. The water content has a great effect on the compressive strength of the carbonaceous slate which decreases by 48.8% under saturation state and its softening coefficient is 0.52. After excavation, the underground water is developed and outcropped (Fig. 14). Moreover, the downslope was excavated over 50 m, and the unload rebound crack/fracture of rock mass is serious. As a result, the downslope is easy to fail and the deposit is fragmented (Fig. 3). Without the reinforcement of the downslope, the middle portion of the landslide gradually deforms and many tension cracks are formed. The A5 area

Fig. 14 The outcropping of the spring water

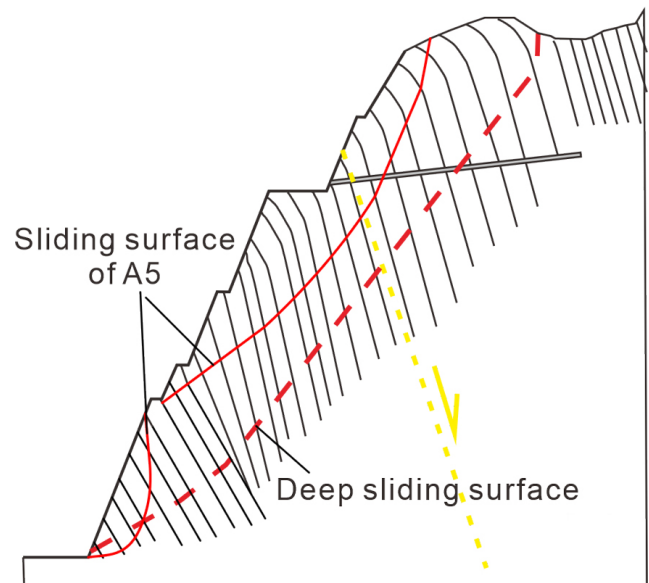
In conclusion, under the integrative action of the fault, unloading, gravity, in situ stress and groundwater, the toppling rock slope's upward progressively bending and deforming. The bending rock layer pushes and compresses the middle and front parts of the slope. The dynamic load is the main factor causing the failure of the slope. In the initial stage of excavation, the rate of dumping deformation increased, the horizontal displacement led to the protrusion of the slope, the vertical downward displacement increased rapidly, and the uphill part of the slope was deformed and affected to a greater depth. In the late stage of excavation, the deformation of the rock slope decreases and the slope gradually self-stabilizes. At the same time, under the softening of groundwater and compression of rock mass, the middle and uphill parts of the A5 area slipped and is cut out from the first berm path, while the lower rock mass is compressed and broken, and local collapse occurred (Fig. 15). The upper part of the slope produces many local collapses.

Fig. 15 Failure model of the Jiacha slope
