Failure Mechanism of the Toppling Rock Slope with Different Numbers of Free Faces Caused by Excavation: a Case Study in Jiacha Hydropower Station (China)

Shao-Ping Huang^{1,2}, Kai-Ming Cao^{1,2}, Chang Zhou³, Heng-Lin Xiao^{1,2}, E-Chuan Yan^{4*}, Lu Cong⁵

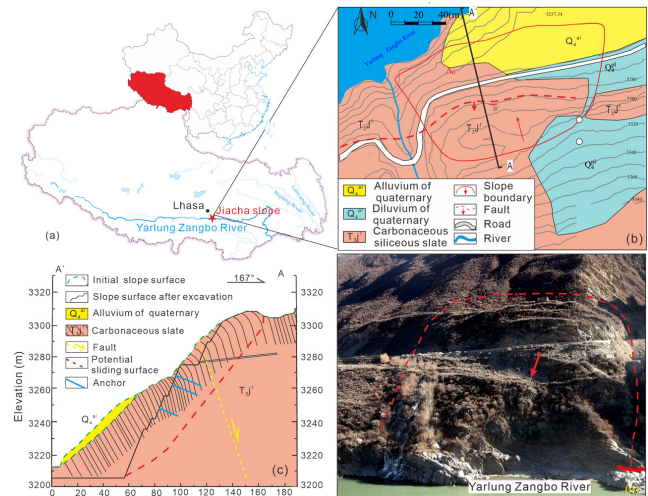
Fig. 1 a) The Location of the Jiacha slope; b) Topographic and structural outline map; c) Cross-section profile of the slope; d) Panoramic view of Jiacha slope before excavation

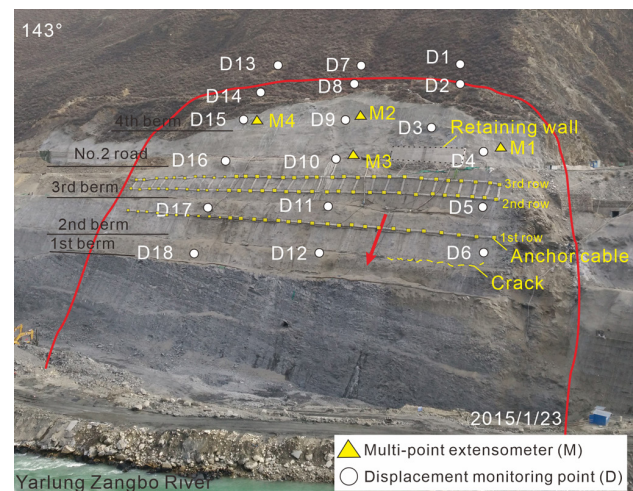
was equipped to record the deformation characteristics of the slope (Fig. 2). Eighteen temporary monitoring points (D1–D18) were installed on the surfaces of the slope. The spacing of the monitoring points is about 26 m along the sliding direction. Four multi-point extensometers were installed on the upslope. One extensometer contains five measurement units with a vertical spacing of 10 m, 15 m, 20 m, and 25 m from the shallow part of the slope to the inside.

Fig. 2 Monitoring system of the toppling soft rock slope

Some cracks were found at the toe of the second berm on 23 Jan 2015 (Fig. 2). The field investigation found that the deformation of the slope accelerated after the blasting on 28 Jan 2015. Many cracks were mainly generated in the middle and uphill part of the slope. On 1 Feb 2015, there was some rockfall on the downhill of the slope surface, and the uphill part of the A5 failed. At 8:46 a.m., the A4 and the downhill of the A5 area rapidly collapsed and accumulated at the toe of the slope. At 7:30, 4 Feb 2015, the rapid collapse of the rock mass behind the A5 area had led to the formation of two free faces at this collapse site, and the No. 2 road and anchor cable system failed. Consequently, the collapse broke in the front part of the slope, and the rock mass was flaky. Many tensional cracks developed on the slope surface, and some cracks ran through the slope. Furthermore, some shear cracks were found during this process.

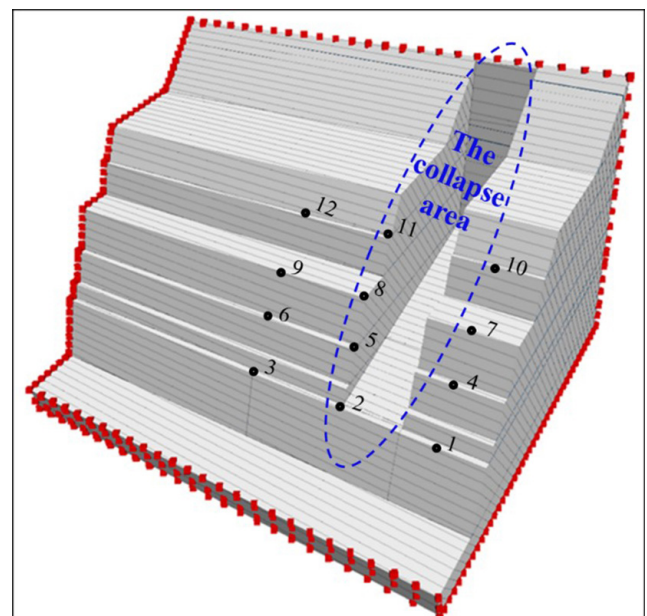
The lithology of the geological model was set as sandstone and slate. The rock thickness was set to 10 m (average rock thickness). This model range of the Z-axis, Y-axis, and X-axis was 0–150 m, 0–270 m, and 0–210 m, respectively.

Fig. 10 A simplified model for numerical simulation

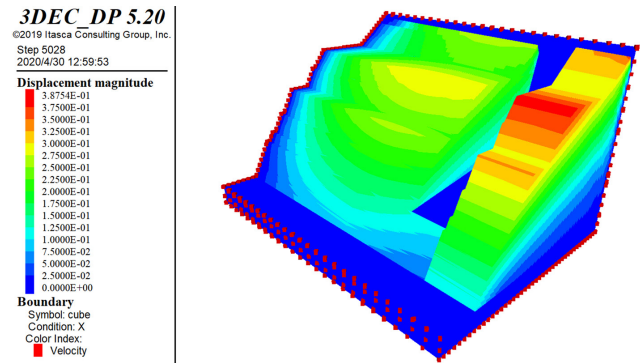
The influence of the numbers of free faces on the displacement was revealed by 3DEC. From the results of the simulation, it is clear that the slope with three free faces has the largest deformation, the displacement contour shown in Fig. 11. From the results presented above, it is well recognized that the numbers of free faces caused by excavation has a significant impact on the stability of slopes. Furthermore, the slope with a free face primarily undergoes a "U" shaped outward bulging deformation in the middle of the free face. In addition, it is also clear that 'Book-style' bending toppling occurs on the slope with two free faces, its displacement decreased from the slope surface to the inside and from upslope to downslope, and the slipping surface is fan-shaped. At the same time, it can be also observed that the deformation of the slope with three free faces decreased from the slope surface to the inside and the shape of the sliding surface is linear, this will further evolve into a linear fracture and the overall failure will occur. The numerical simulation results presented above reveal that more free faces could increase the probability of slope instability, and thus it should be emphasized that the excavation of multiple free faces should be avoided in the process of engineering construction as much as possible and the preventive engineering measures should be performed on the slope in time.

Fig. 11 Displacement cloud map of numerical simulation

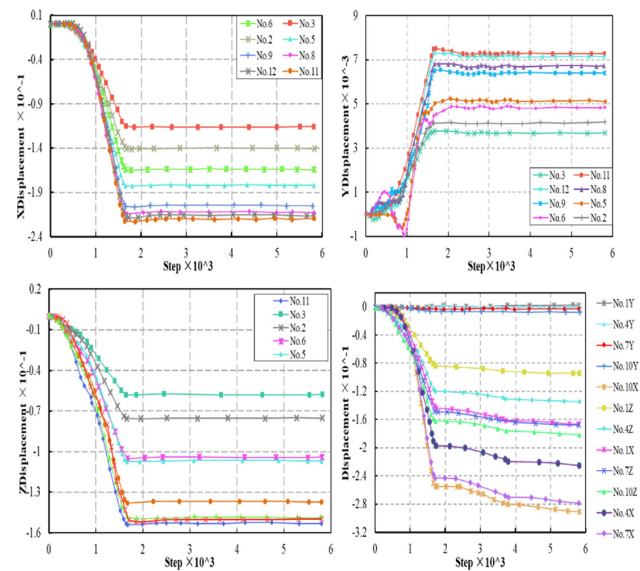
In order to systematically and deeply study the number of free faces as a key factor affecting the deformation characteristics of toppling rock slope, 12 monitoring points were set up on the model (Fig. 10). The displacement of these monitoring points under different analysis steps and in different directions as illustrated in Fig. 12. And it can be clearly observed that all of the curves in

Fig. 12 Monitoring displacement curves of numerical simulation
