The Impact of Natural Fibers on Thermal Resistance and Spalling in High-performance Concrete

This article presents an experimental approach to evaluate the effectiveness of palm fibers as a natural innovative solution to enhance the thermal resistance of high-performance concrete (HPC) under fire conditions. The utilization of palm fibers aims to promote local materials, since locally sourced materials may be more affordable due to their abundance. Four different high-performance concrete formulations were tested. The first, called HPCSF, which is composed of fibreless silica fumes, served as a reference mix. The second, HPCPSF, included the addition of polypropylene fibers to silica fume. The third, HPCDFSF, integrates date palm fibers with silica fume. Finally, the fourth, HPCPQSSF, combined polypropylene fibers with varying amounts of quarry sand and silica sand, in addition to silica fume. The results of the fire resistance tests show that the incorporation of palm fibers into the concrete mixture improves structural strength, reduces spalling, prevents crack formation under high-temperature conditions, and increases fire resistance in HPC.

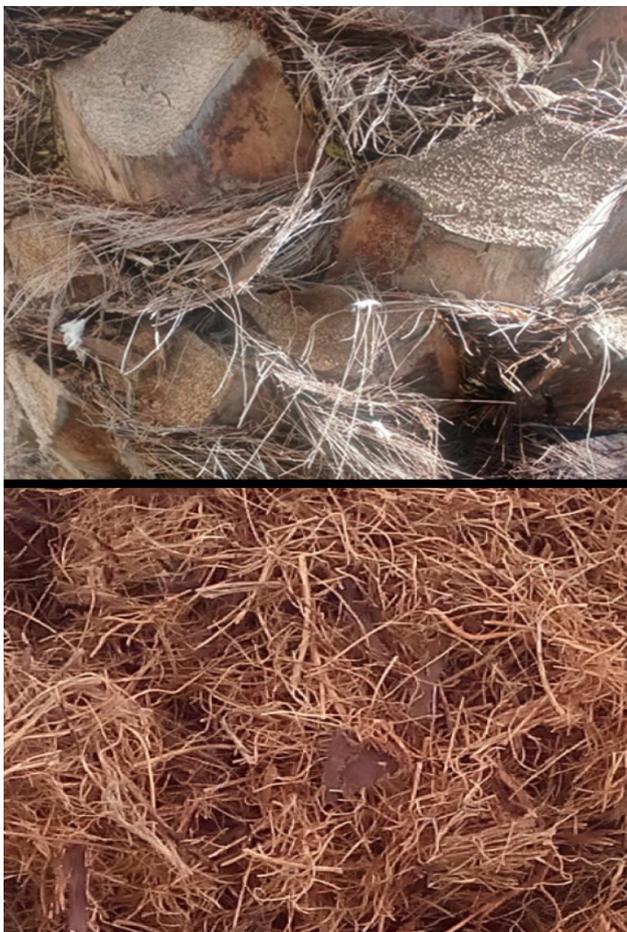
In this investigation, the focus was on fibers of the Dokar variety, sourced from the date palm plant, as depicted in Fig. 1. Drawing from the research conducted by Kriker et al. [30], which examined four types of fibers harvested from the exteriors of the date palm varieties Dokar,

Fig. 1 Illustrations of palm fibers

Deglette-Nour, Degla-Bida, and Elguers (using their local nomenclatures), Dokar fibers were identified to possess superior tensile strength. Consequently, Dokar fibers were selected for inclusion in our study. The physical and mechanical properties of Dokar fibers are delineated in Table 5 [31]. Within the HPCDFSf mixtures, Date palm fibers, with a length of 30 mm and a diameter of 0.30 mm, were added at a rate of 1.85 kg/m³. These fibers begin to thermally degrade at around 250 °C and usually fully decompose between 450 °C and 500 °C.

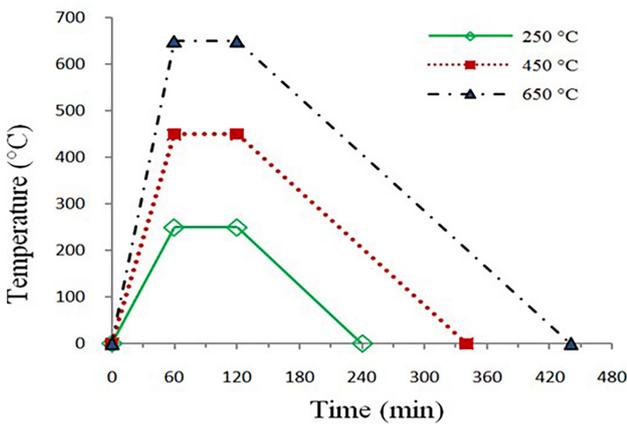
Fire resistance tests were performed on the four samples by exposing them to fire on all sides after a severe fire scenario. The temperature gradually increased from the starting ambient temperature of 20 °C to three unique levels: 250 °C, 450 °C, and 650 °C. The heating procedure took 60 minutes at an average rate of 8 °C per minute, with maximum temperatures held for one hour. Following that, the examined samples were subjected to cooling settings designed to imitate ordinary building fires. The outcome of each test is the average of three cubic concrete specimens. Fig. 2 depicts the furnace's heating and cooling curve. The Fig. 3 shows the furnace that was used during the experimentation process.

Fig. 2 Curves of heating and cooling according to temperature

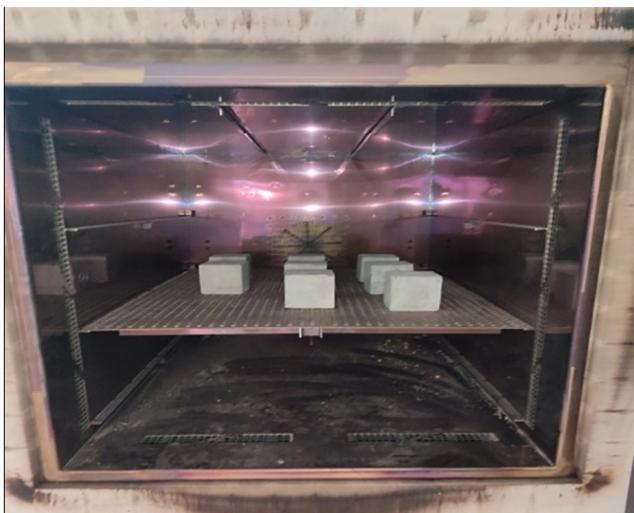
Fig. 3 Naberthen furnace

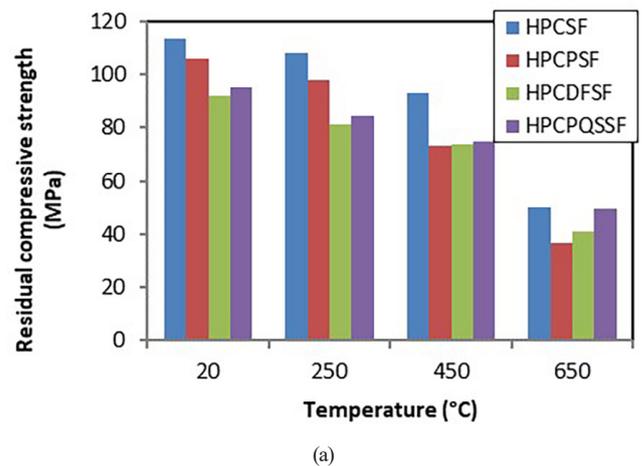
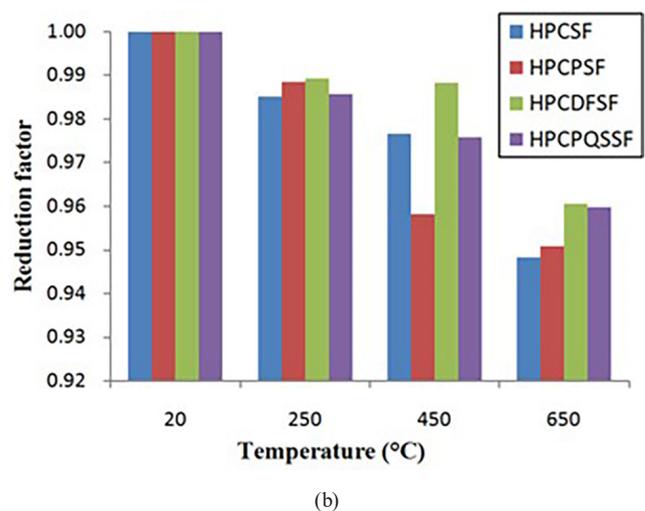
According to literature reviews [19, 32], the properties of concrete subjected to high temperatures are influenced by various factors, including initial strength, composition of materials, age of the concrete, moisture content, among others. It is widely acknowledged that both standard-strength and high-performance concrete exhibit a marked reduction in compressive strength when exposed to rapid temperature increases, typical of fire conditions [33]. This study involved analyzing and comparing samples from different concrete formulations, as illustrated in Fig. 4.

Fig. 4 (a) Compressive strength of all concrete types as a function of temperature, (b) Compressive strength reduction factors of all concrete types as a function of temperature

This research emphasizes the beneficial effect of integrating palm fibers as an alternative to polypropylene in enhancing the fire resistance of high-performance concrete (HPC). Notably, Fig. 4 (b) reveals that after three hours of exposure to elevated temperatures, a 65% reduction in concrete strength was recorded, mirroring the loss observed with polypropylene fibers. These encouraging outcomes underscore the potential of palm fibers as an effective replacement for polypropylene in improving the fire resilience of HPC.

The compressive strength reduction factor determined in this study can be compared with those suggested by Eurocode 2 [34], which recommends the reduction factor for normal weight concrete with silica aggregates. However, all samples exhibit values slightly higher than those recommended by the Eurocodes standards, especially within the temperature range of 250 to 450 degrees Fig. 4 (b).

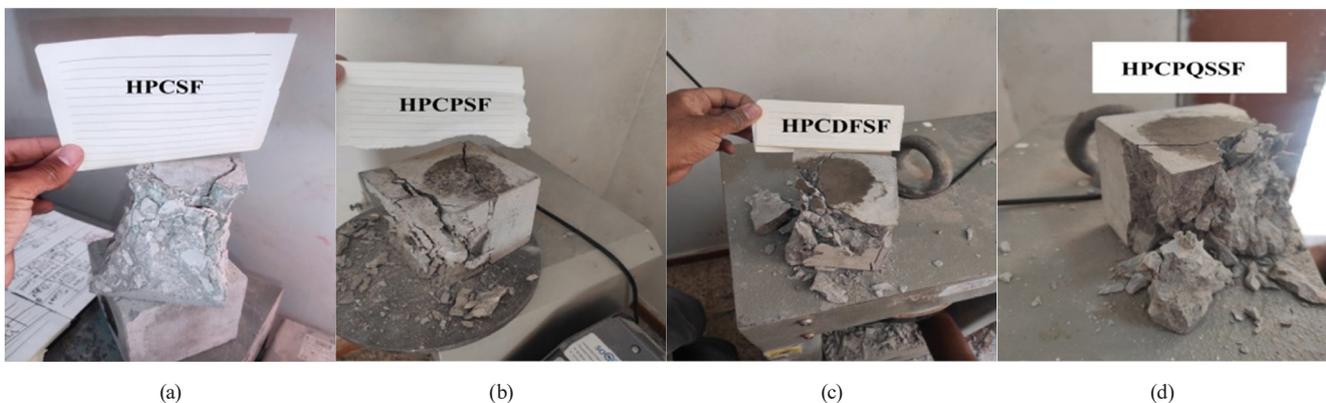
The findings related to the residual compressive strength at ambient temperature (20 ± 2 °C) and following exposure to temperatures of 250, 450, and 600 °C are documented in Table 7, with each entry representing the mean of three specimens. Table 6 clearly demonstrates a decline in the compressive strength of concrete as the temperature rises. The average residual compressive strengths, in comparison to those at room temperature, were observed to be between 88% to 95% at 250 °C, 69% to 82% at 450 °C, and 35% to 52% at 650 °C. The visual appearance of the samples after exposure to 450 °C, prior to compressive strength testing, is presented in Fig. 5.

Fig. 5 The condition of the samples after testing their compressive strength after exposure at 450 °C: (a) HPCSF 450 °C, (b) HPCPSF 450 °C, (c) HPCDFSF 450 °C, (d) HPCPQSSF 450 °C

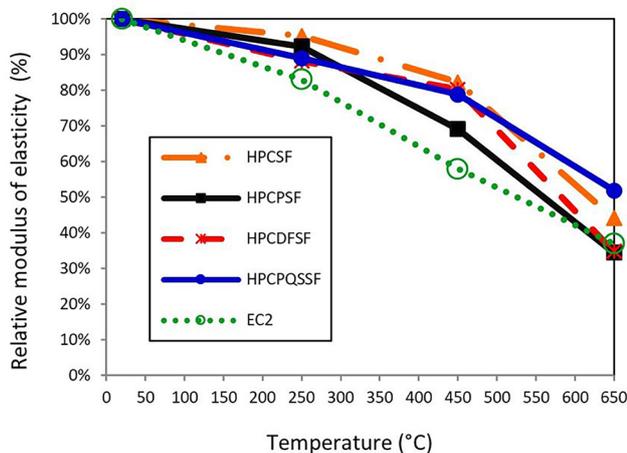
The modulus of elasticity of concrete is consistently related to its initial compressive strength. However, as shown in Fig. 6, the series of curves for all types of concrete studied show performance superior to those recommended by Eurocode 2 [34], with differences varying between 12% and 24% over a temperature range of 250 °C to 650 °C. The largest differences occur at a temperature of 450 °C. Additionally, palm fiber concrete HPCDFSF and polypropylene concrete HPCPSF showed significant degradation beyond 450 °C compared to other types of concrete. This seems logical because fibers generally have a negative effect on the elastic modulus; this has been demonstrated by research conducted by Hager and Pimienta [35]. The elastic modulus reduction factors are summarized in Table 9.

Fig. 6 Relative modulus of elasticity of all types of concrete as a function of temperature

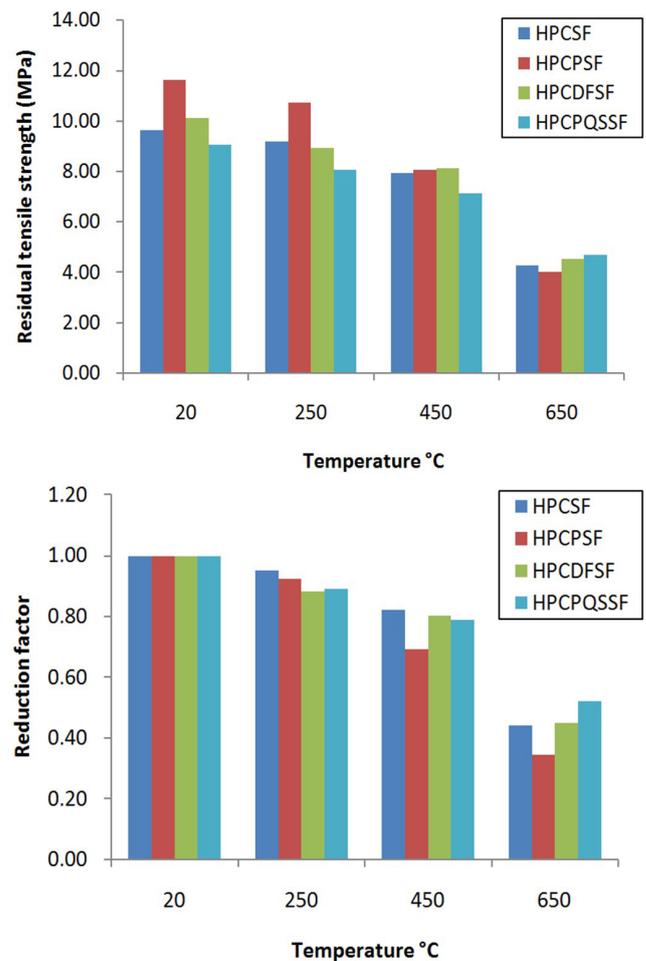
Fig. 7 clearly illustrates a continuous and linear drop in flexural strength up to 450 °C for all concrete samples. The curves describe the change in residual tensile strength as a function of temperature for various kinds of concrete. However, a notable loss in strength is shown in every instance as the temperature above this 450 °C threshold. In particular, concrete that incorporates palm fibers shows a relatively acceptable flexural strength compared to other types of concrete, exhibiting only a 55%

Fig. 7 Residual tensile strength of all concrete types as a function of temperature

reduction, similar to the outcome observed with polypropylene-based concrete.

This result arises from the ductile nature of the internal structure of these fibers, which enhances the flexibility of the concrete and prevents the formation of cracks, thus improving its flexural resistance [27, 36, 37].

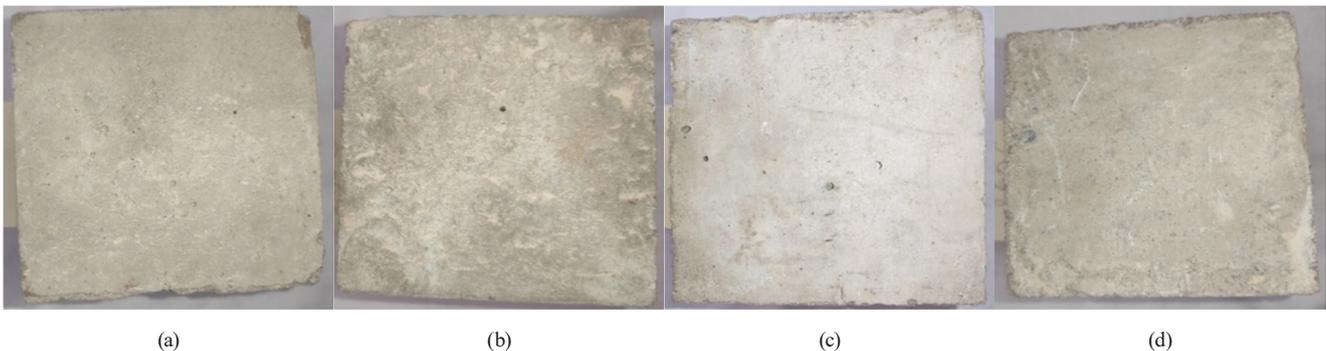
An important aspect of this study involves the examination of the impact of palm fibers on the resistance of HPC to spalling. Following exposure to different elevated temperatures, we recorded observations related to physical characteristics, including spalling frequency, color alterations, and crack formation, to assess their behavior under high-temperature conditions. Figs. 8–10 illustrate the concrete surfaces after being treated at high temperatures. An initial assessment of the potential damage due to high temperature exposure can be carried out by examining the external properties of the concrete surface. It is evident that the surface of the samples heated to 250 °C shows no noticeable changes (Fig. 8). However, the cracks in the concrete surface began to manifest at approximately 450 °C (Fig. 9) and continued to worsen as the temperature

Fig. 8 Condition of the concrete surface at 250 °C: (a) HPCSF 250 °C, (b) HPCPSF 250 °C, (c) HPCDFSF 250 °C, (d) HPCPQSSF 250 °C

However, it is crucial to emphasize that all types of concrete showed robust resistance to spalling. Despite the presence of several raised bumps on the surface, severe concrete spalling was not observed in these samples, even when exposed to temperatures as high as 650 °C. Fig. 10 illustrates the state of these specimens after exposure to a temperature of 650 °C. When analyzing concrete samples with palm fibers (Fig. 10 (c)), it becomes evident that the spalling phenomenon is entirely absent. Furthermore, this type of concrete shows no cracks up to 450 °C, and its surface remains intact up to 650 °C, at which point we observed the appearance of some surface cracks. This clearly illustrates the positive impact of using palm fibers to prevent concrete spalling at high temperatures. This observation has significant economic value by reducing potential costs associated with the use of polypropylene fibers to mitigate spalling in concrete. The utilization of palm fibers proves to be effective not only in terms

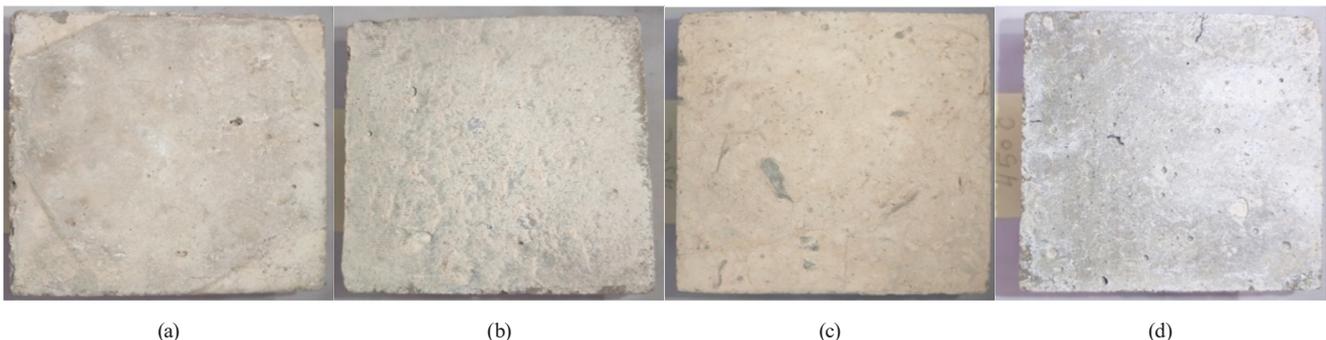
Fig. 9 Condition of the concrete surface at 450 °C: (a) HPCSF 450 °C, (b) HPCPSF 450 °C, (c) HPCDFSF 450 °C, (d) HPCPQSSF 450 °C

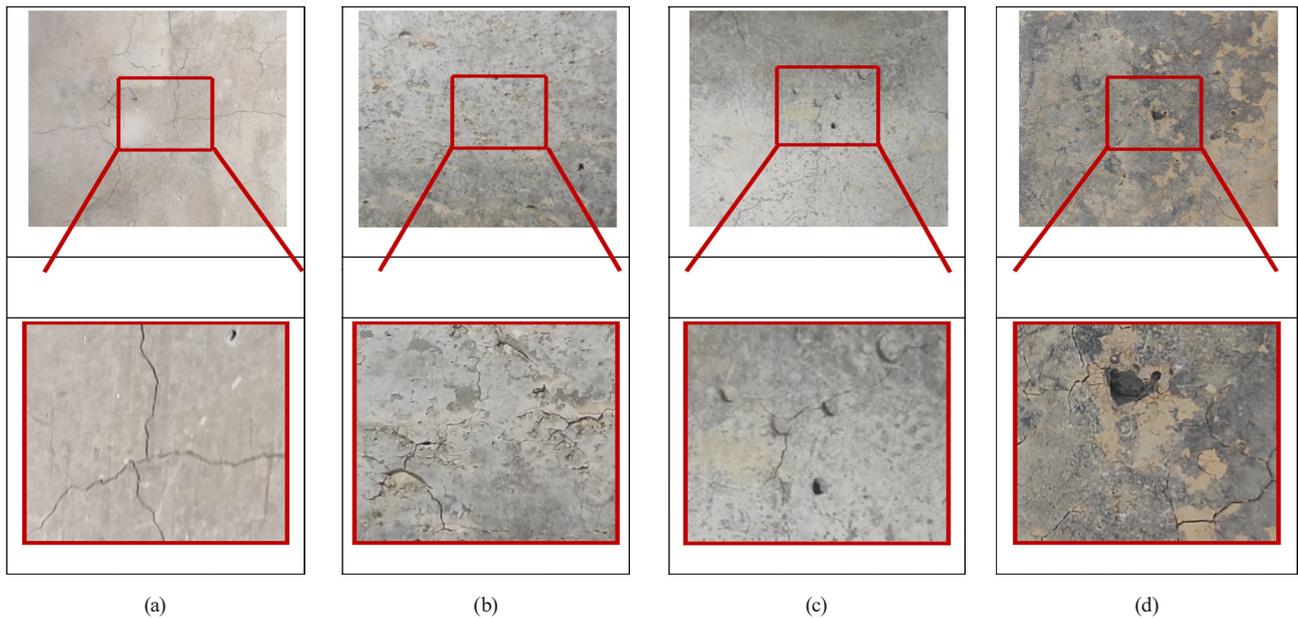
increased, reaching their peak at 650 °C. After exposure to temperatures exceeding 600 °C, HPCPQSSF concrete, which includes polypropylene fibers along with varying proportions of quarry sand and siliceous sand, exhibited light brown discoloration, accompanied by the development of numerous cracks and surface bumps as shown in Fig. 10 (d). Furthermore, Fig. 10 illustrates a color change, providing a visual indication of a notable alteration in the properties of concrete for all types of concrete.

Fig. 10 Condition of the concrete surface at 650 °C: (a) HPCSF 650 °C, (b) HPCPSF 650 °C, (c) HPCDFSF 650 °C, (d) HPCPQSSF 650 °C

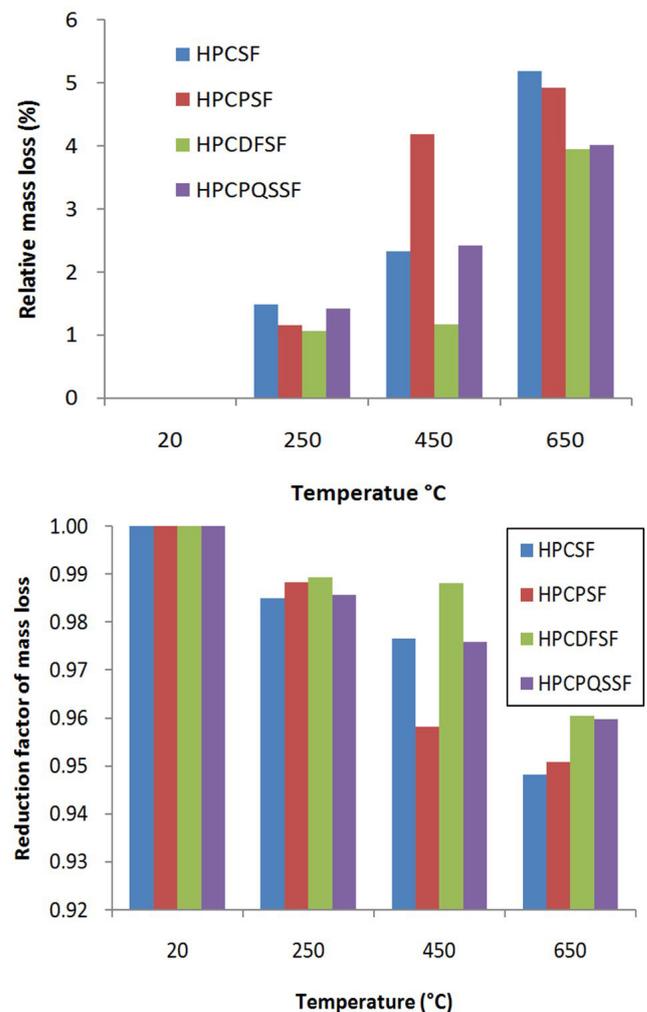
To assess mass loss, we measured the weight of the cubic samples before and after their exposure to elevated temperatures, as shown in Fig. 11. This representation highlights how the increase of temperature influences the reduction of the concrete mass samples. The correlation between variation in mass loss and temperature is clear for all four types of concrete examined, as noted by several authors [37–39]. They found that the variation in mass loss as a function of temperature exposure is linked to the presence of water in the concrete in free, bound, or adsorbed form, which gradually escapes and represents the main cause of the loss of concrete mass. These authors identified three phases in the evolution of mass loss.

- In the first phase, from room temperature to 150 °C, a slight loss of approximately 3% was observed, corresponding to the release of water contained in the capillary pores.
- Between 150 and 300 °C, a significant increase in mass loss is observed.
- Above 300 °C, a slowdown in mass loss is observed. The main physicochemical transformation undergone by the heated concrete between 150 and 300 °C is the dehydration of CSH.

Fig. 11 Residual mass loss as a function of temperature

However, all concrete samples examined in the present study exhibited a significant mass loss from room temperature to 650 °C. At 250 °C, the samples (HPCSF, HPCPSF, HPCDFSF, and HPCPQSSF) recorded a mass loss of approximately 3%, 5%, 7% and 10%, respectively. This trend continues with increasing temperature, reaching approximately 3%, 5%, 7%, and 10% at 450 °C. On the contrary, mix having palm fibers experiences minimal mass loss between 250 °C and 450 °C, unlike other types of concrete. This difference can be attributed to the fact that palm fibers only melt at very high temperatures, around 1170 °C [40], thus preserving their internal structure and improving the properties of this type of concrete. Above 600 °C, a significant increase in the rate of mass loss is observed. According to research conducted by Xiao et al. [40] and Zhang [41], the phenomena of splitting or degradation of the concrete surface may be linked to many reasons, including the breakdown of limestone particles and CO₂ emissions. When compared to other mixes, HPCDFSF mixes exhibit comparatively less mass loss, but HPCSF mixes exhibit a more noticeable mass loss than the others. The HPCDFSF and HPCPQSSF blends showed a mass loss of 3.95% at 650 °C, but the HPCSF and HPCPSF blends showed a mass loss of 5.02% at that temperature.

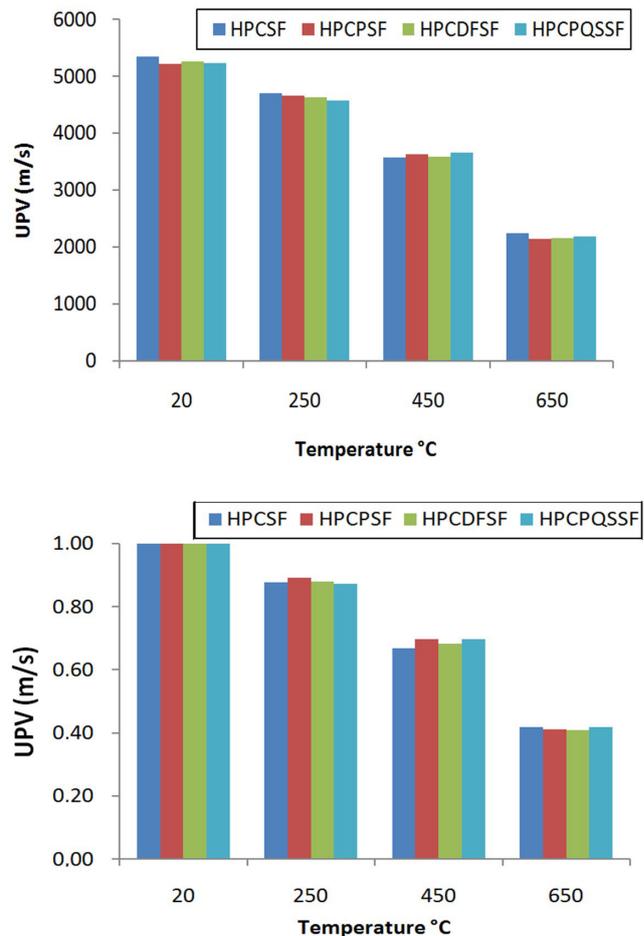
The evaluation of the elastic modulus and material density was performed utilizing an ultrasonic pulse velocity (UPV) test, aimed at examining the structural integrity of the HPCSF, HPCPSF, HPCDFSF, and HPCPQSSF specimens. Fig. 12 graphically depicts the degradation of concrete integrity as determined by ultrasonic pulse measurements. A discernible decline in UPV values across the temperature spectrum from 250 °C to 650 °C suggests an incremental formation of microcracks within the concrete matrix. At 250 °C, the velocity of ultrasonic pulses saw a reduction of 11% in HPCPSF specimens and 12% in the HPCSF, HPCDFSF, and HPCPQSSF specimens. Moreover, a notable decrease of 58% in ultrasonic pulse velocity was observed at 650 °C for all specimens, as illustrated in Fig. 12.

Fig. 12 Temperature-dependent ultrasonic pulse velocity

The observed trends indicate a uniform decrease in ultrasonic pulse velocity across the board for specimens of high-performance concrete at elevated temperatures, signaling a deterioration in their physical properties and structural integrity.

Additionally, the findings from the UPV test further establish that concrete reinforced with palm fibers exhibits comparable outcomes to other tested concrete variants.
